ATTENTION NOTICE

We suggest that all operators with Virtual Rabbids UHD should make the following modification to the headset covers:

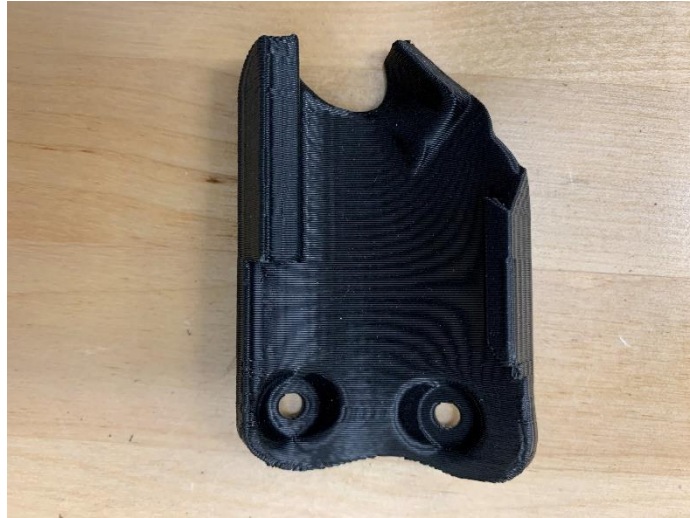
REASON FOR THE CHANGE: Some operators have experienced intermittent laggy video on the top monitor and loss of video in the headsets. This has been determined to be caused by either a loose or failed All-in-One cable. This modification will remove the possibility of a loose cable at the headset connection.

1. Remove the cable cover from the headset cover by removing the two screws.
