ATTENTION NOTICE

We suggest that all operators with Virtual Rabbids UHD should make the following modification to the headset covers:

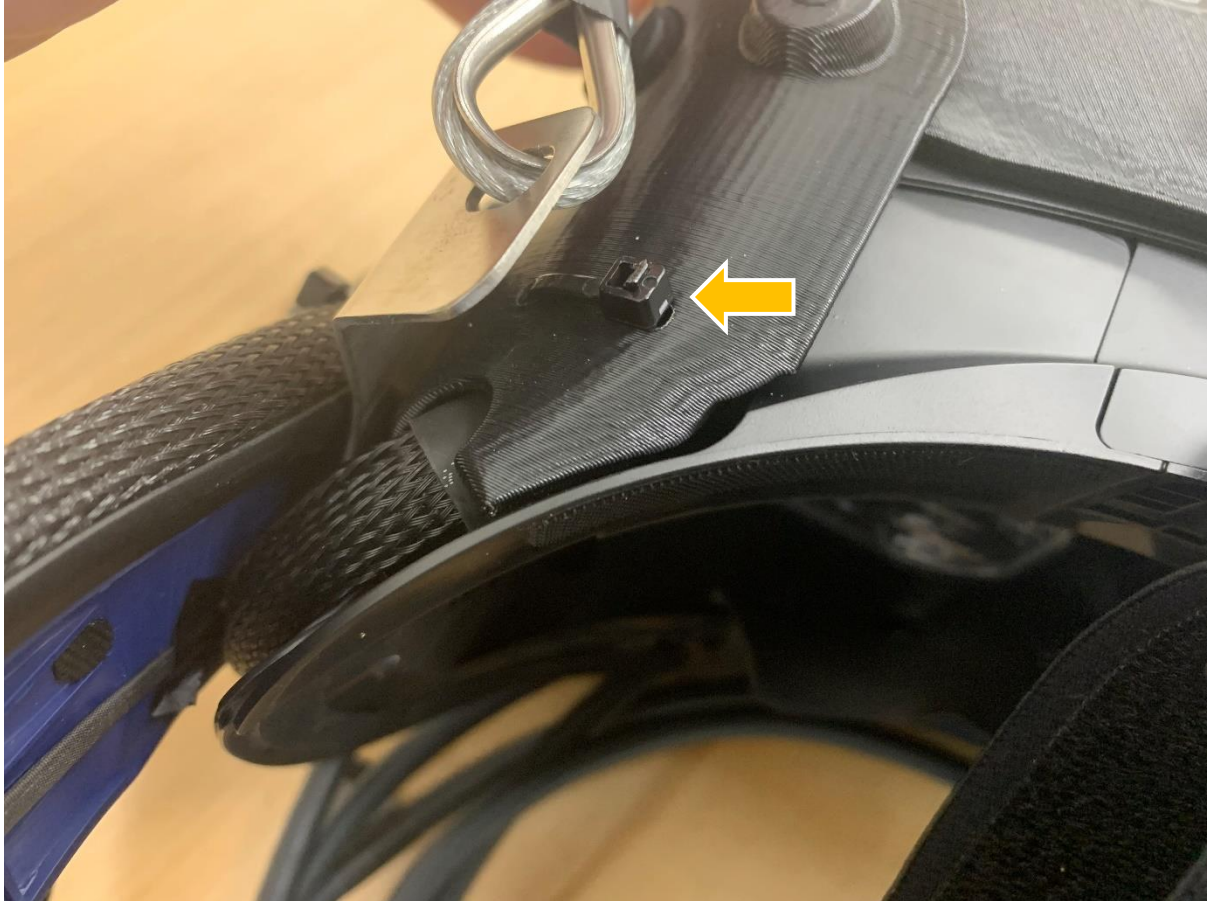
REASON FOR THE CHANGE: Some operators have experienced intermittent laggy video on the top monitor and loss of video in the headsets. This has been determined to be caused by either a loose or failed All-in-One cable. This modification will remove the possibility of a loose cable at the headset connection.
